Speed Data Information Summary:

School Bus Stop Operation Review:

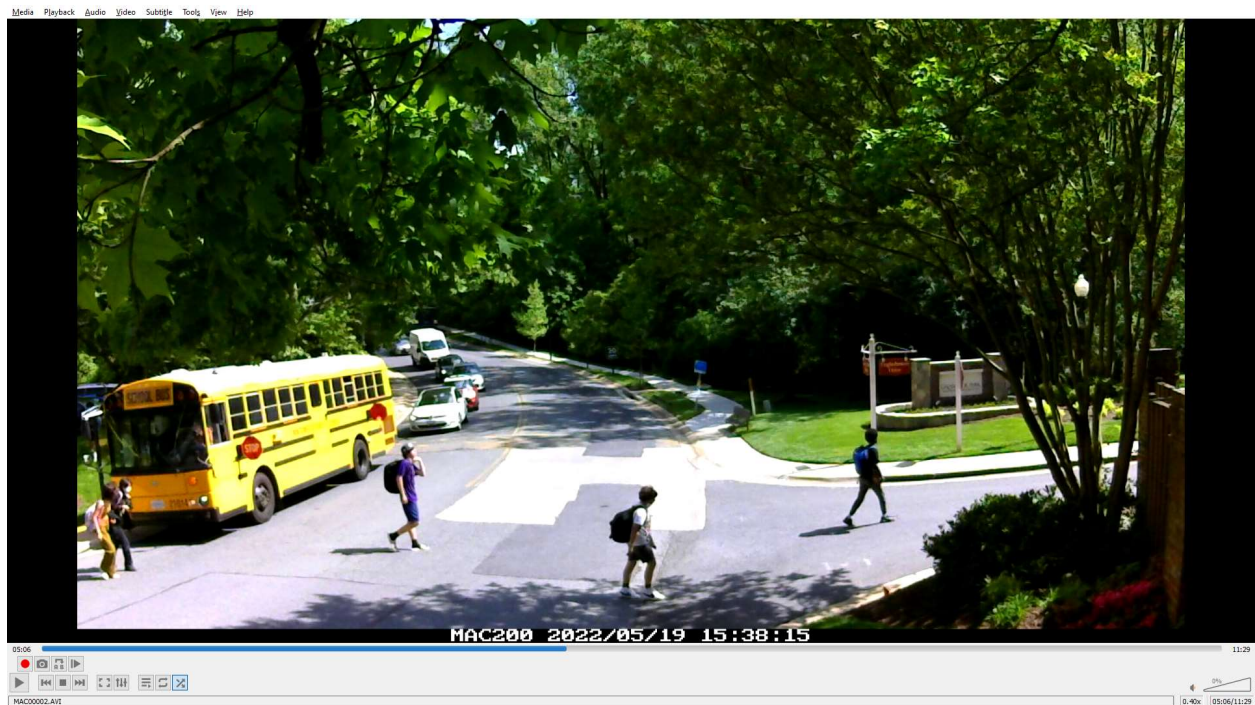
May 19 at 3:38pm Northbound drop-off

Time lapse cameras were used to document how pedestrians use the existing intersection and amenities. The lack of well-defined crosswalks and the random stopping locations of the school buses define the paths used by pedestrians. Below are multiple examples of the random crossings that occur throughout the day.

A new marked crosswalk containing white lines is recommended to be installed crossing Grosvenor Place. Crosswalks are required to have white lines. The existing yellow lines do not establish a proper crosswalk. A new ADA compliant pedestrian ramp should be installed on the east side of Grosvenor Place to provide a proper transition to the existing east side sidewalk from the street level. The existing curb line condition is just a roll type gutter that doesn't meet ADA requirements.

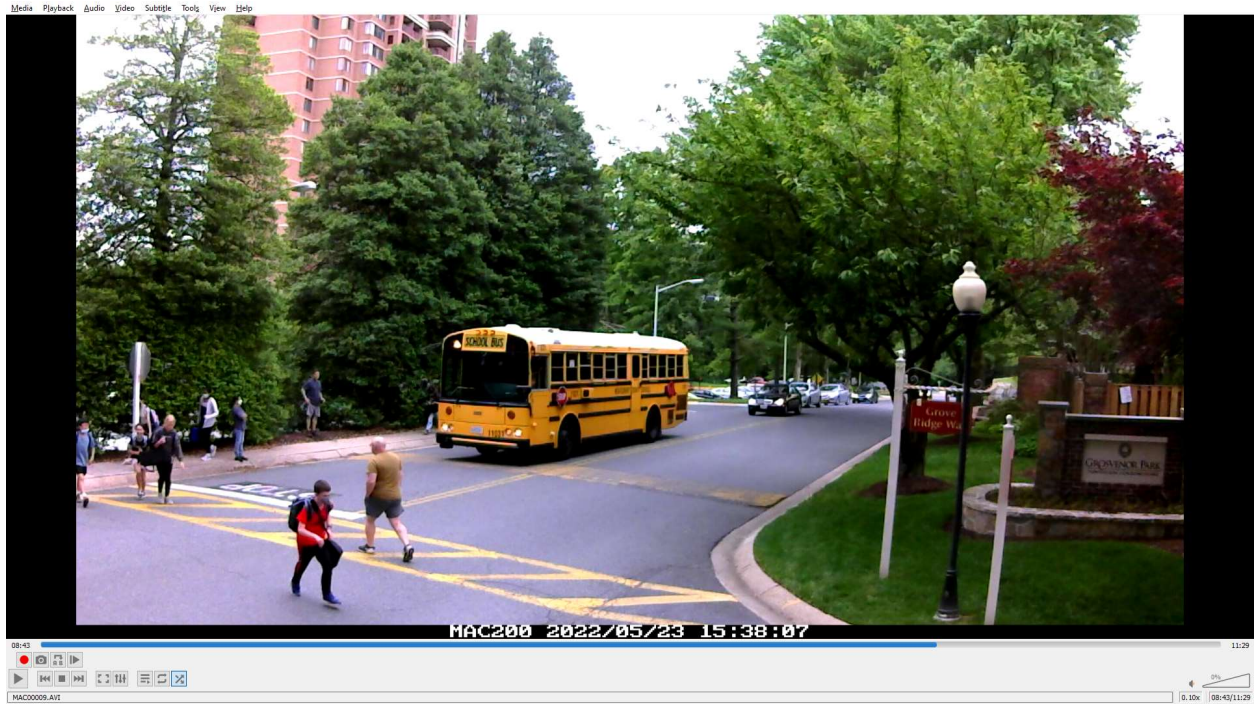
May 23 at 3:38pm Northbound – Parents waiting along sidewalk, other students crossing Grosvenor Place that walked north from the Englishman Intersection Bus Stop.

A new marked crosswalk containing white lines should be installed crossing Grosvenor Place. Crosswalks are required to have white lines. The existing yellow lines do not establish a proper crosswalk. A new ADA compliant pedestrian ramp should be installed on the east side of Grosvenor Place to provide a proper transition to the existing east side sidewalk area. The existing curb line condition is just a role type gutter that doesn't meet ADA requirements.

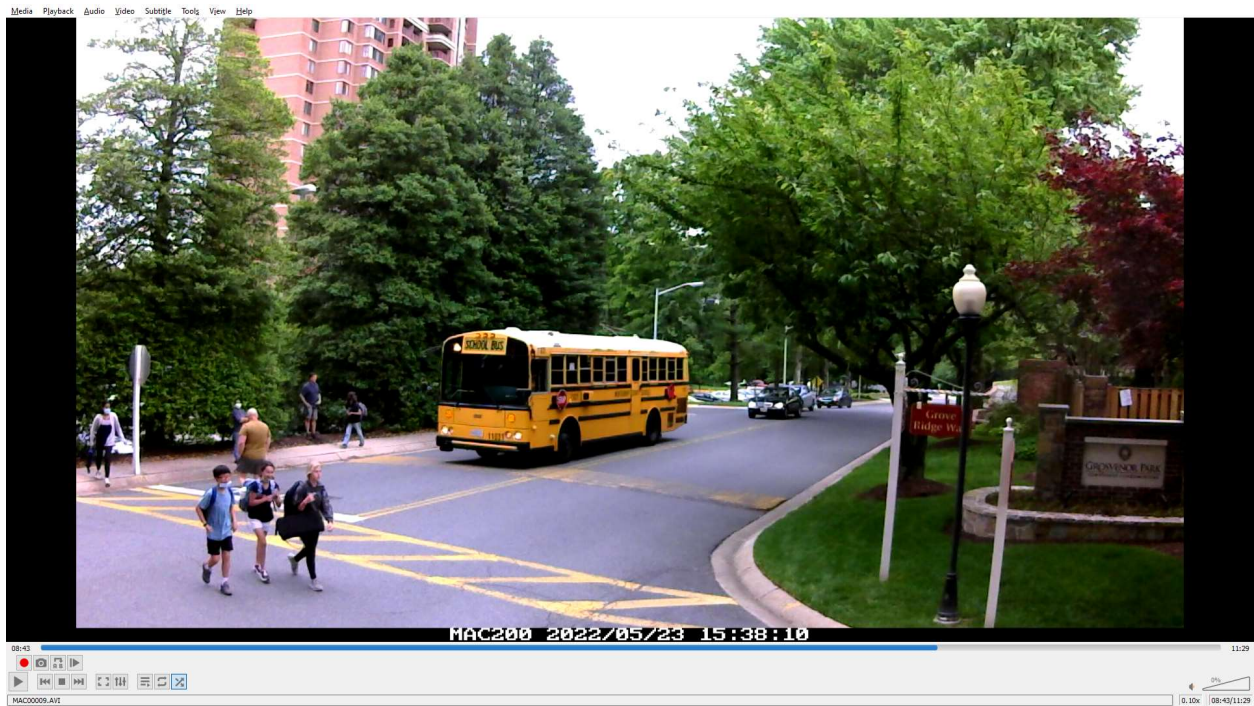
May 23 at 3:38pm Northbound – Parents waiting along sidewalk, students not using crosswalk.

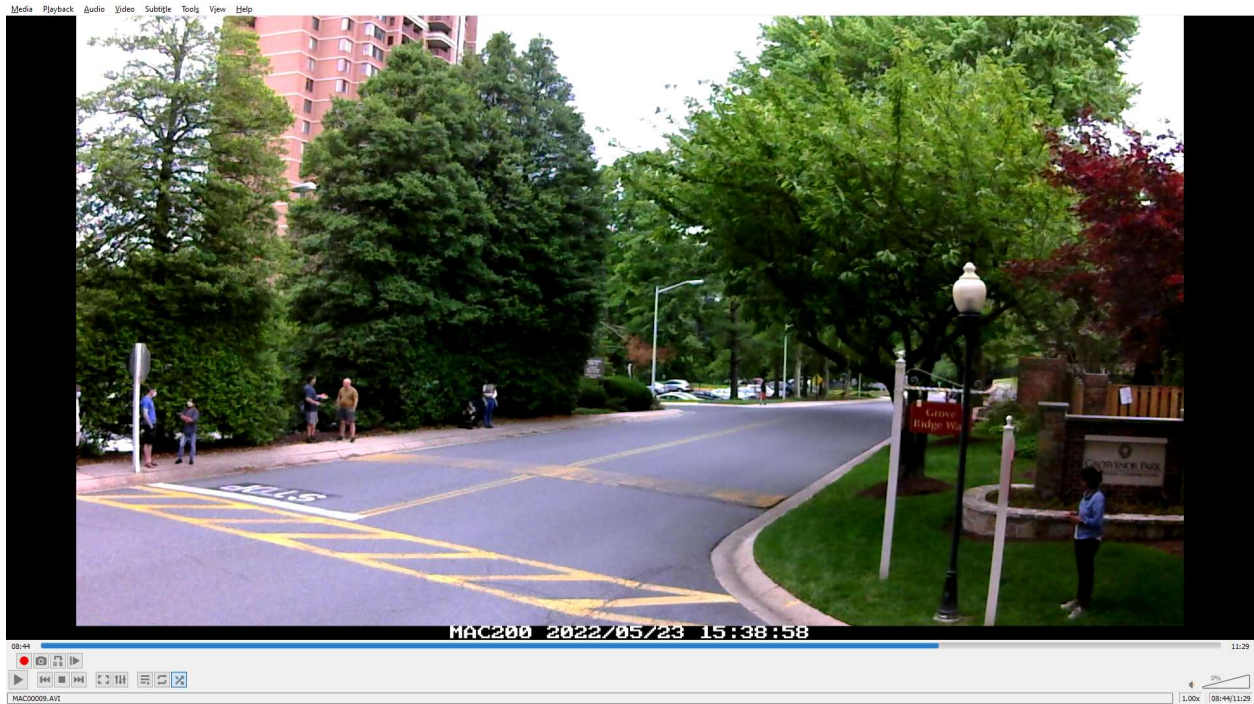
May 23 at 3:39pm Northbound, waiting parents

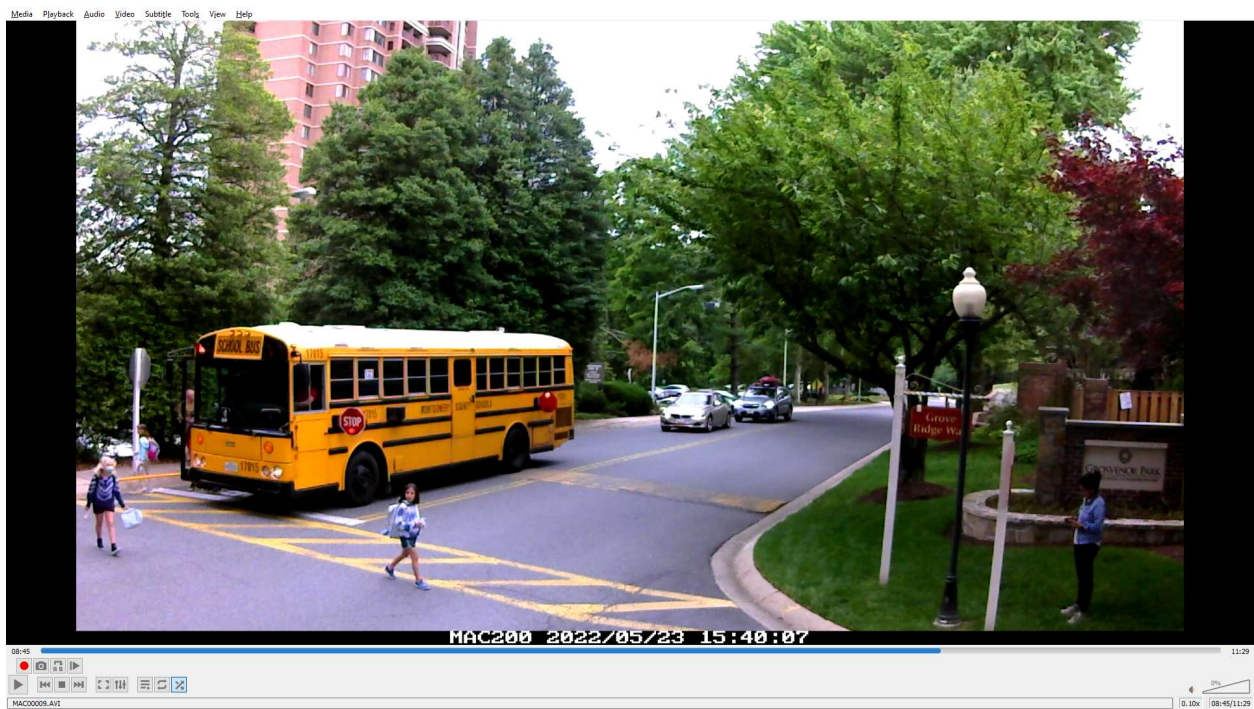
May 23 at 3:40pm Northbound drop-off, younger students not using crosswalk.

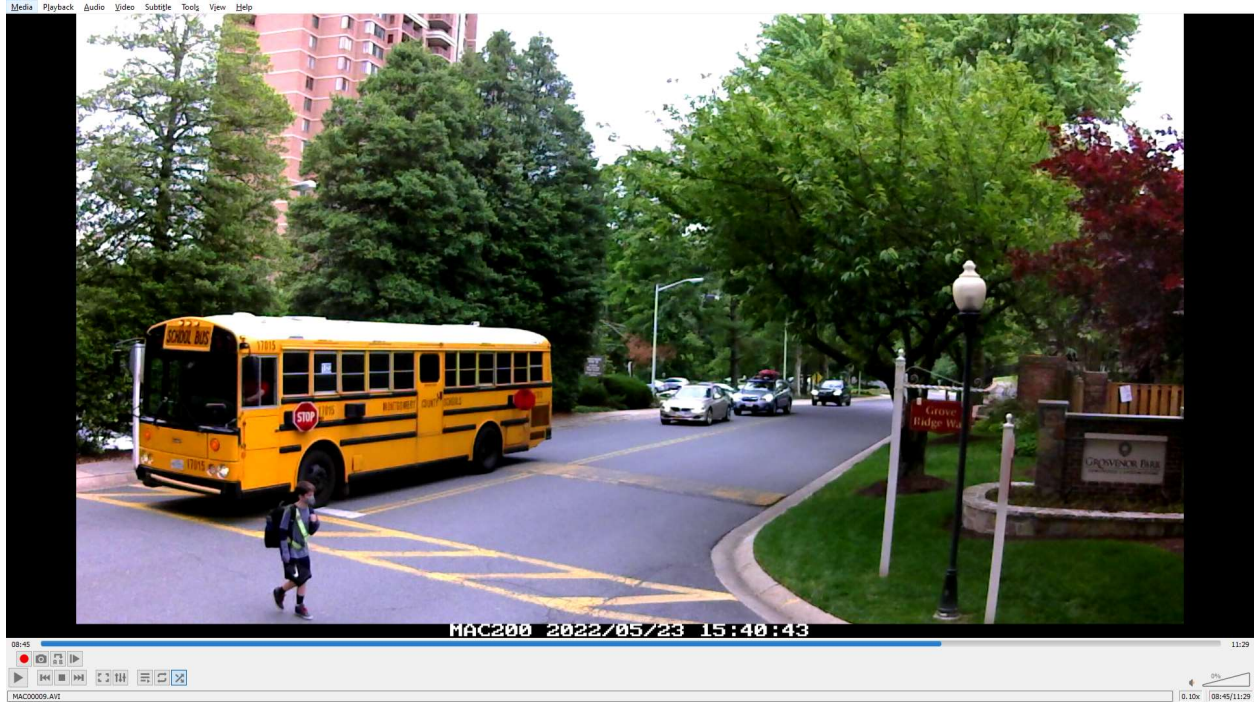
May 23 at 3:41pm Northbound drop-off, Bus moving while child still in the roadway with lights off.

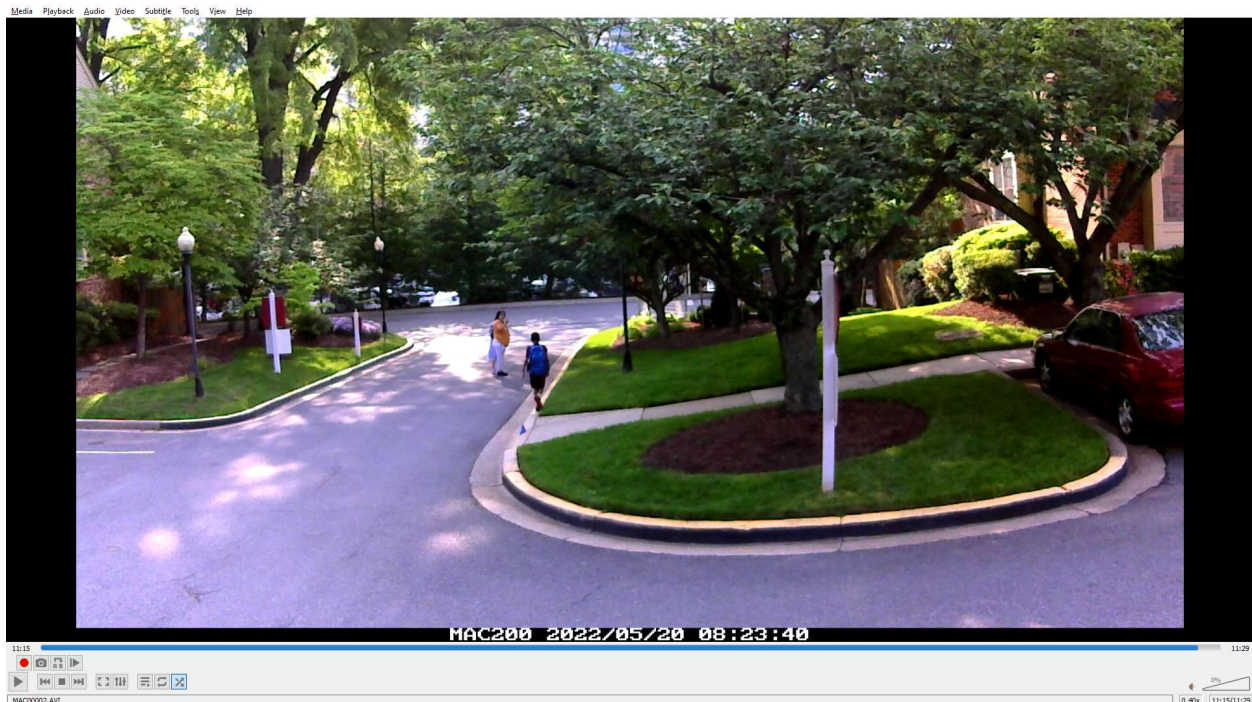
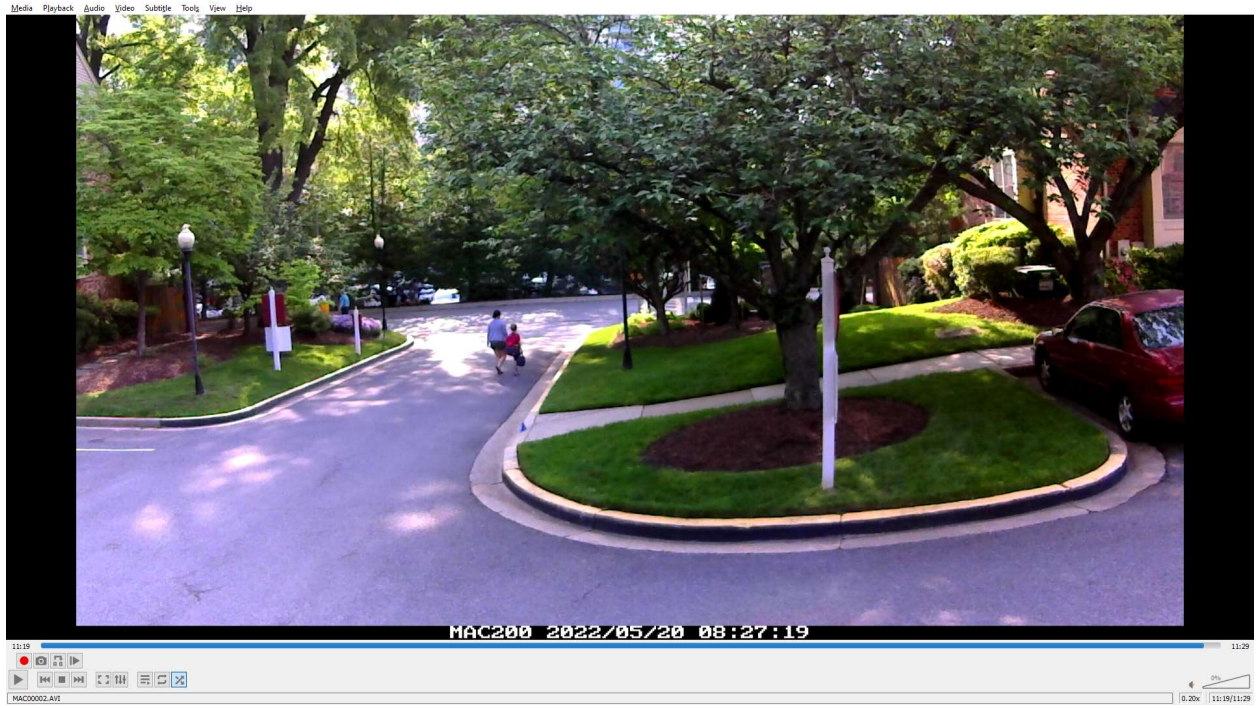
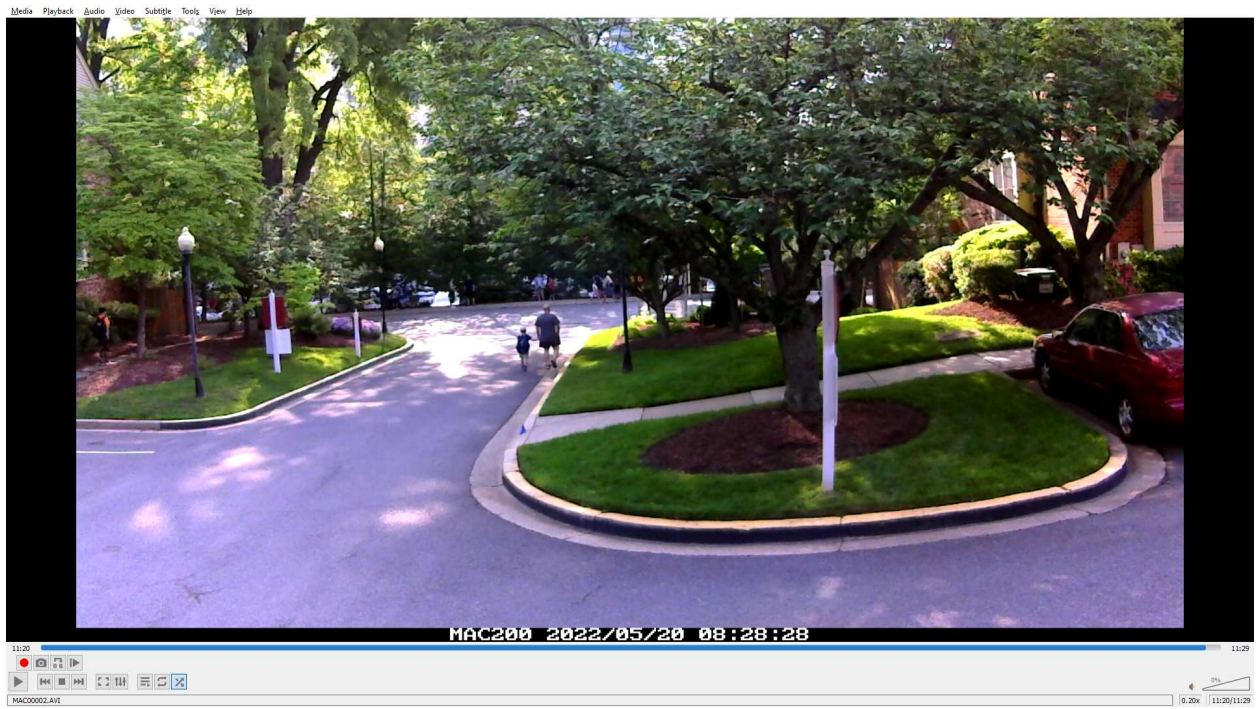
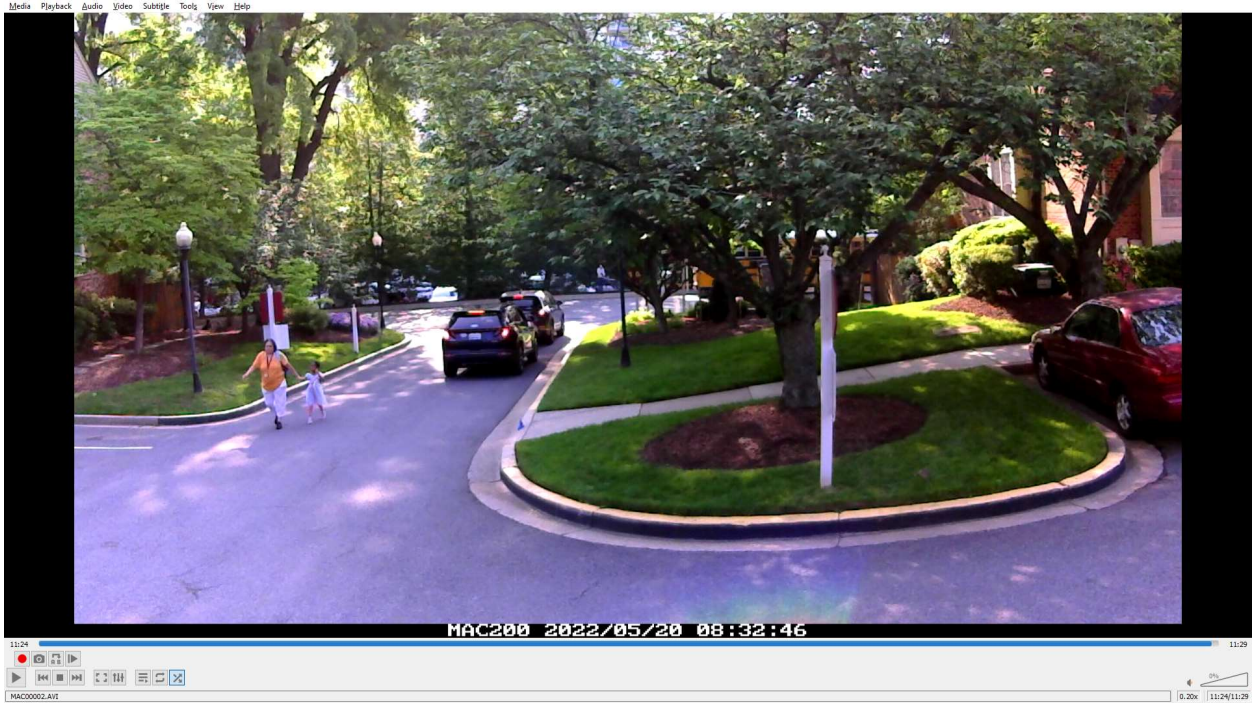
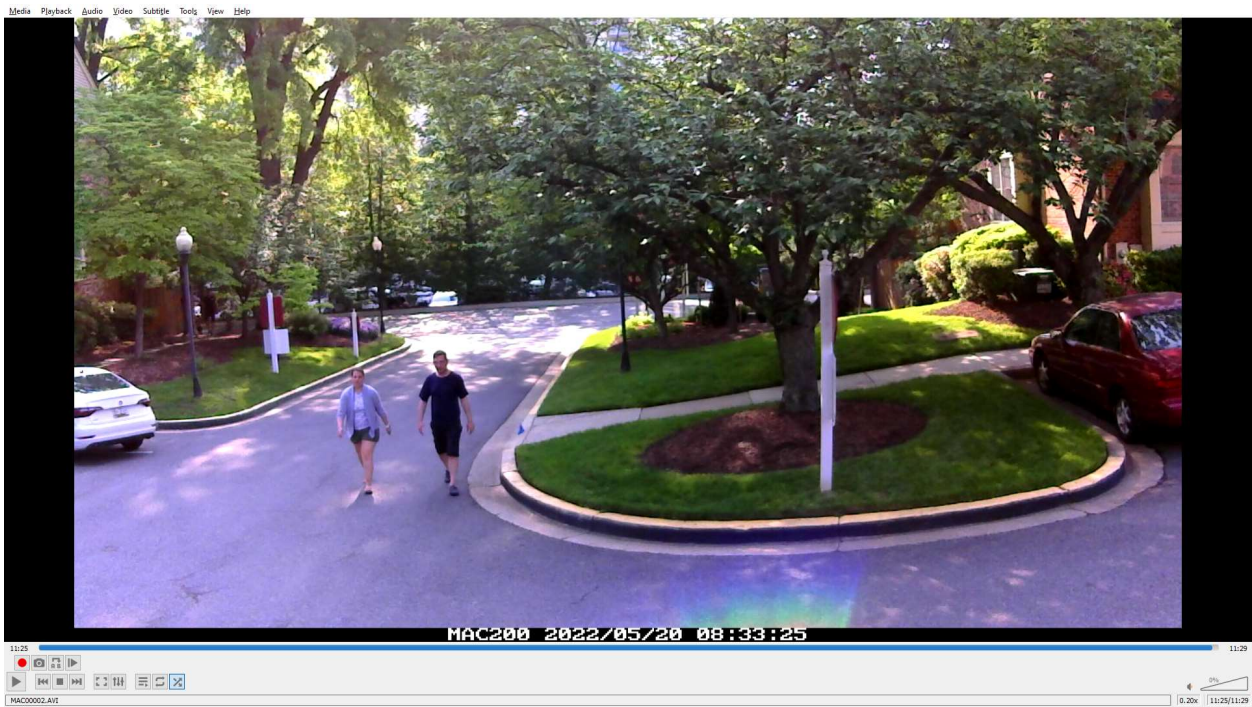
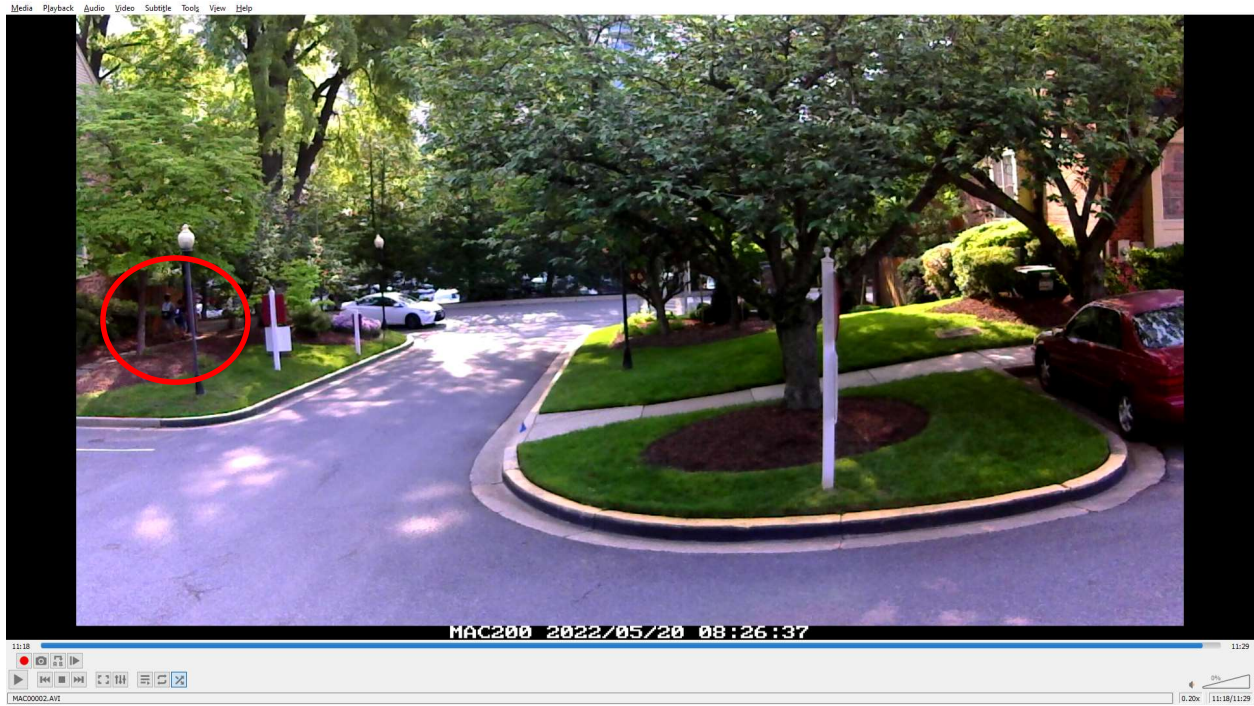
Grove Ridge Way Access at Grosvenor Place Intersection:

On multiple occasions pedestrians were observed walking within the street on the southern side of the access (Grove Ridge Way). On multiple occasions pedestrians that used the street area to walk in /out of the community also interacted with multiple vehicles in and out of the community creating a very unsafe condition. Few pedestrians were observed using the existing walkway path on the northern side. The existing walkway path along the north side of Grove Ridge Way is made up of large “railroad ties” retaining wall type materials, consisting of wood, concrete, and slate squares. This path climbs up and over an elevated landscaped area and unfortunately touches down along Grosvenor Place roadway approximately 35 Feet north before the intersection of Grove Ridge Way. Pedestrians that use the north side pedestrian path connection to access Grosvenor Place find themselves at the existing curb edge about 2 vehicle lengths too far north and end up crossing the street in between stopped vehicles and other vehicles slowing down to stop. Pedestrian crossings should only occur directly from the intersection corner in front of a stopped vehicle and not set back from the intersection.

Recommendation: Install a new 5 ft. wide sidewalk along the southern curb line of Grove Ridge Way connecting to the Grove Ridge Court sidewalk on the west and the southwest corner of Grosvenor Place on the east. The existing northern sidewalk connection should be maintained to provide the residence (6

A new Raised Crosswalk is recommended to cross pedestrians to/from the north side of Grove Ridge Court to the southern side to access Grosvenor Place frontage.

The new sidewalk should include an ADA compliant pedestrian ramp at the corner of Grove Ridge Way and Grosvenor Place (southeast corner).

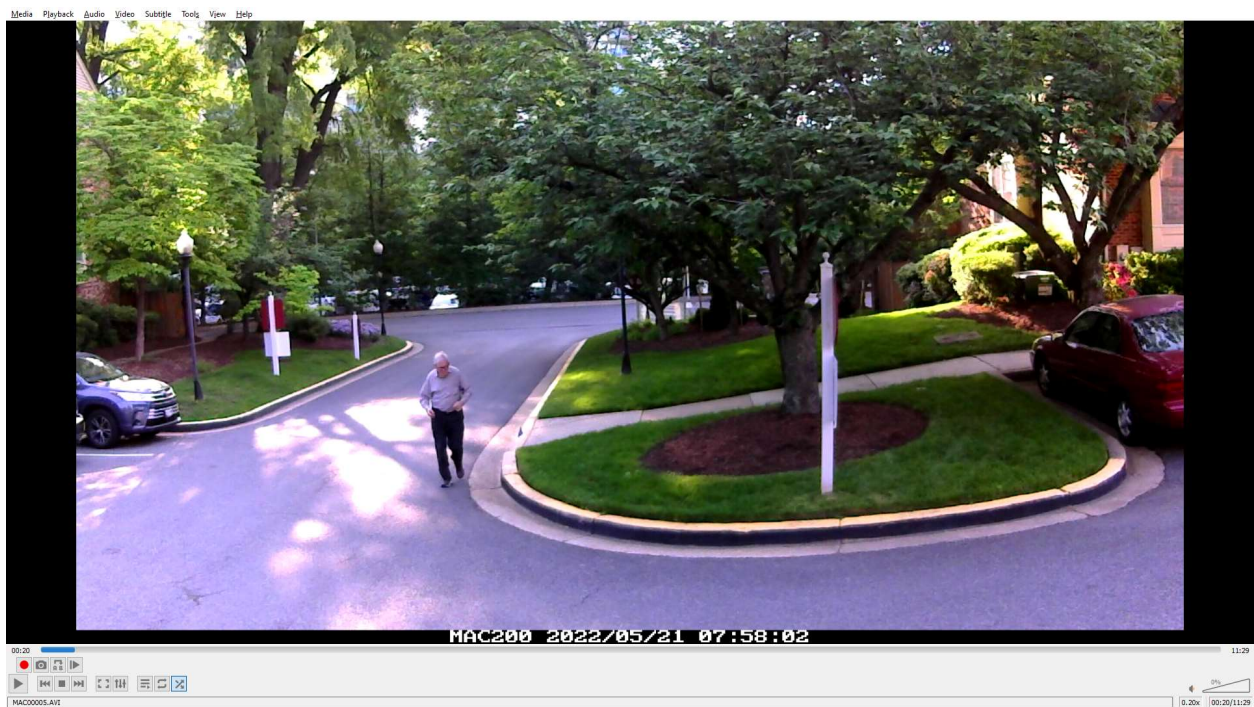
Note: Red circle highlights that some pedestrians do use the existing sidewalk.

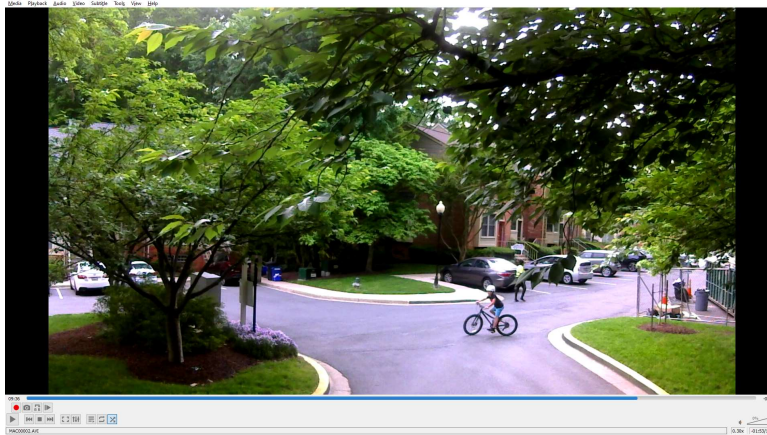
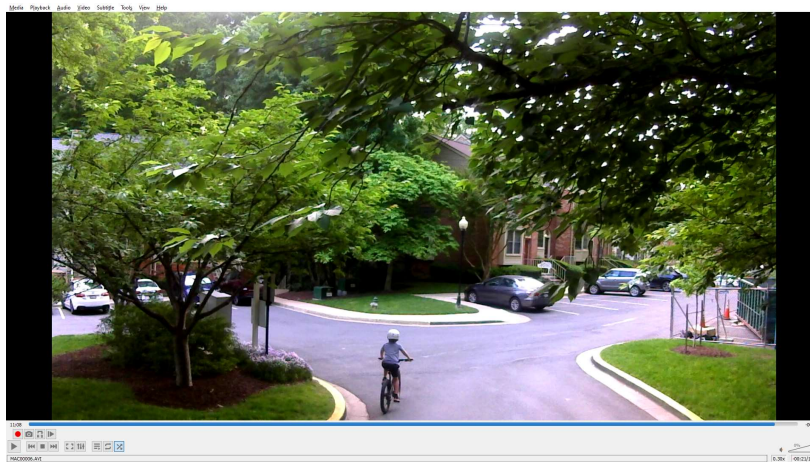
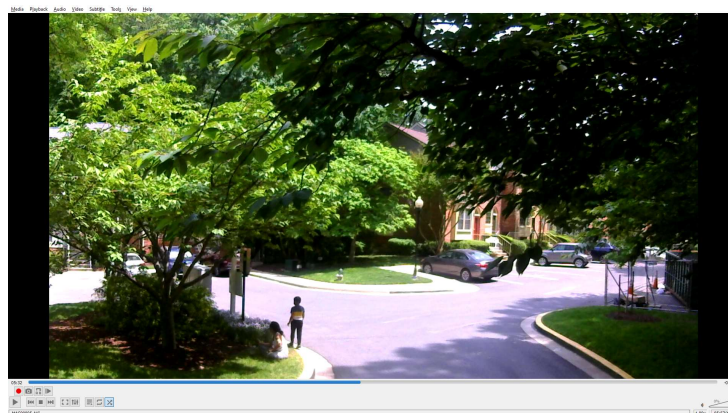
End of Englishman Drive

Children play within the circle area, riding bikes around the island and gathering at the southeast end of the island. While there appears to be children playing in the street, speeds in the general area were observed at reasonable speeds. Safe stopping sight distance to this area at the recorded speeds provides enough area to avoid conflicts. Children should be warned to stay as alert as possible for approaching vehicles and to take a safe position along the curb line and if possible, out of the paved area to avoid injury.

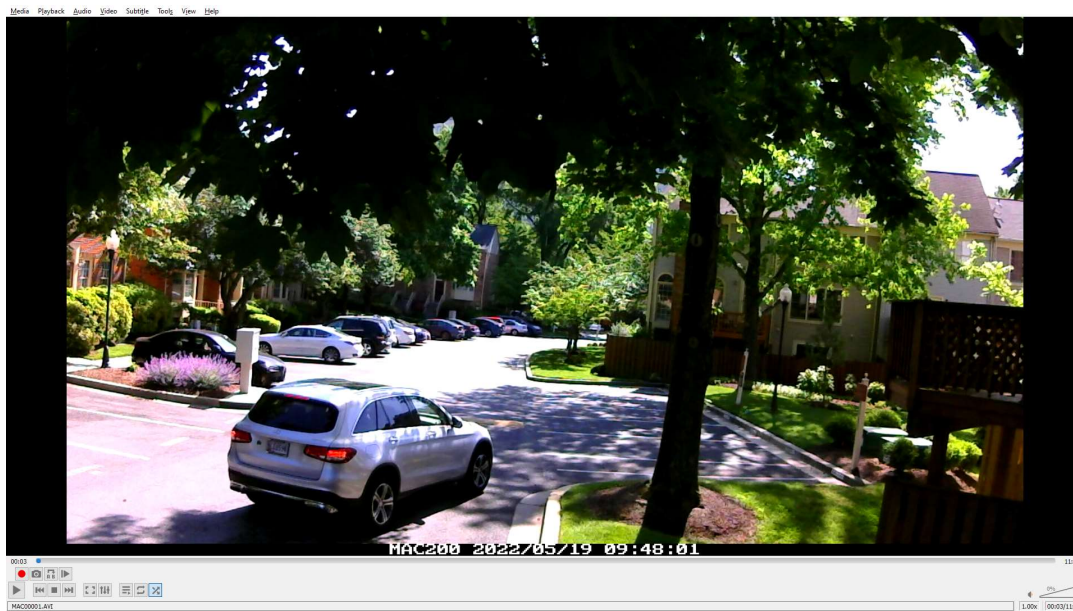
Existing Speed Bump adjacent to the existing Motorcycle Spaces: When the parking spaces are empty adjacent to this speed bump, vehicles were observed on multiple occasions driving around the bump to avoid it all together. Vehicles were observed avoiding the speed bump even in the opposite direction.

Recommendation: Remove the existing bump and install 1 new bump one parking space to the west (1 space closer to the tree within the photograph). This shift of the speed bump 1 space to the west will make it difficult to maneuver around the bump at a higher speed in either direction. The shift will create a parking space area along the north side of Grove Ridge Way but the space of one missing parked vehicle will not allow vehicles to drive around the bump at a higher speed.

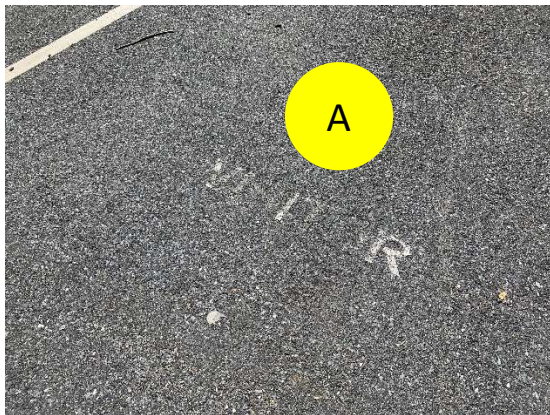
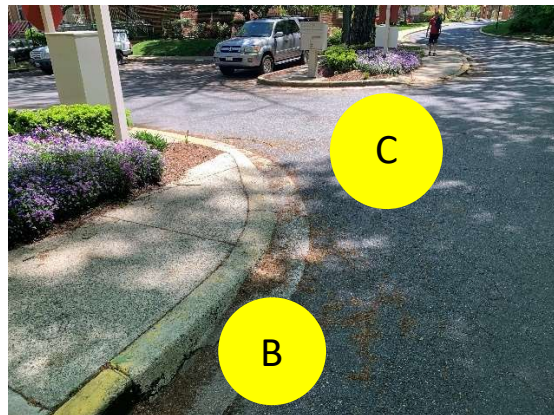
- A. Pavement markings were observed faded and sometimes unreadable. Should be repainted.
- B. Yellow curb areas were observed faded in some areas. Should be repainted.
- C. Crosswalk should provide clear marked pedestrian path with white lines.

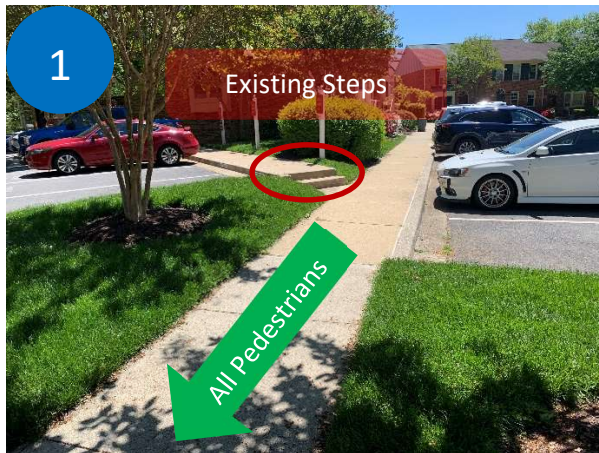
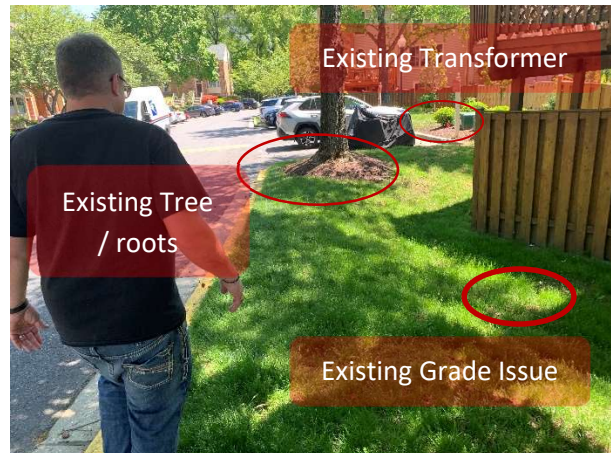
Grove Ridge Way Pedestrian Path / Sidewalk

The existing property terrane along the south side of Grove Ridge Way makes it almost impossible to provide a pedestrian path connection from Grove Ridge Place to Grosvenor Place. There are 2 existing steps, an existing swale (grading drop on the side of the home just west of the existing dedicated motorcycle parking spaces along with a large root structure tree directly adjacent to the motorcycle spaces. Just beyond the curb line in front of the motorcycle spaces there are 2 transformers that are slightly elevated above grade.

Recommendation: All pedestrians to/from the southeast corner of Grove Ridge Place at Grove Ridge Way should cross to the north side of Grove Ridge Way. The plan details a new raised crosswalk to facilitate crossing at this point. The Raised crosswalk will reduce speeds along this road link even more.

The existing landscaped Island 4 parking spaces to the west of the new Island can be removed to maintain the same number of parking spaces.

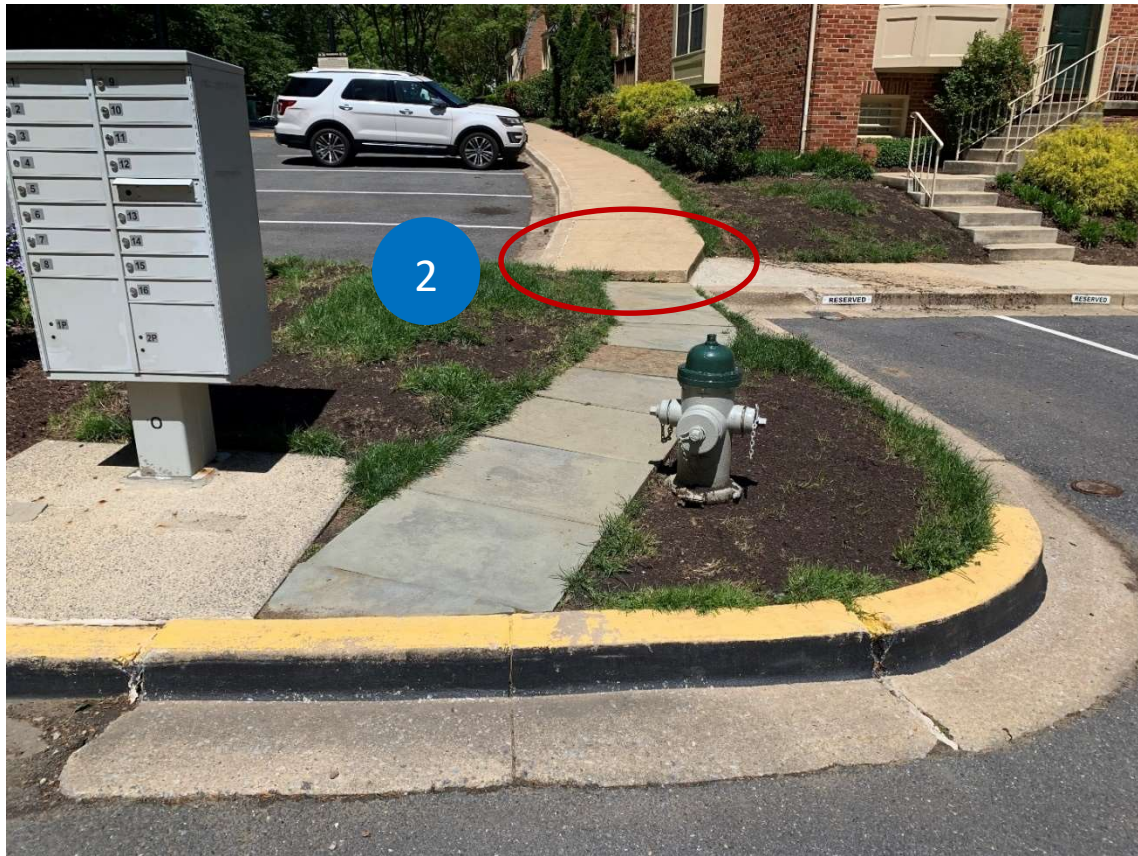
2. Englishman Court at Englishman Drive

The left side of the access to Englishman Court, adjacent to the existing mailbox and the fire hydrant contains a step between the two abutting sidewalks.

Recommendation: See Plan - The sidewalk area in front of the home should be removed and replaced to tie into the existing higher sidewalk. The Slate tiles should be removed and replaced to tie into the higher sidewalk area to provide a continuous accessible path to the street. Lowering the top portion of the existing sidewalk closest to the vehicle would result in a more severe sidewalk grade approaching the grass area. A new ADA compliant ramp should be installed so pedestrians can access the street level without stepping down. A new crosswalk with white lines should be installed.

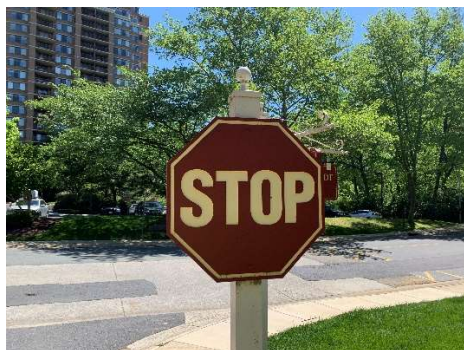
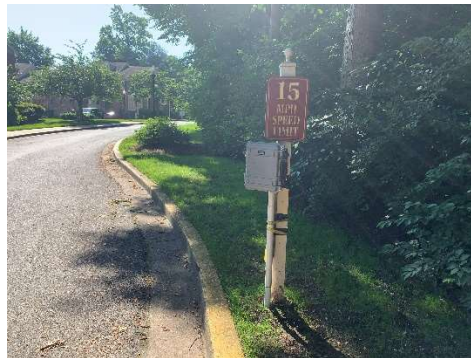
The existing stop signs and the existing speed signs are all decorative in nature but do not meet the Manual on Uniform Traffic Control Devices (MUTCD). These signs should be the proper color, size and contain reflective sheeting that makes them more visible during nighttime. Additionally, signage within residential communities that matches those more commonly seen on government roadways and within traffic rule guidelines are more likely to be obeyed.

Recommendation: Replace the stop signs and speed signs to match the specification sheets attached to this report and as shown on the site drawing. The Traffic Calming ahead signage should also be added to warn visitors / guest that traffic calming devices are present. See plan for size info.
