Speed Data Information Summary:

School Bus Stop Operation Review:

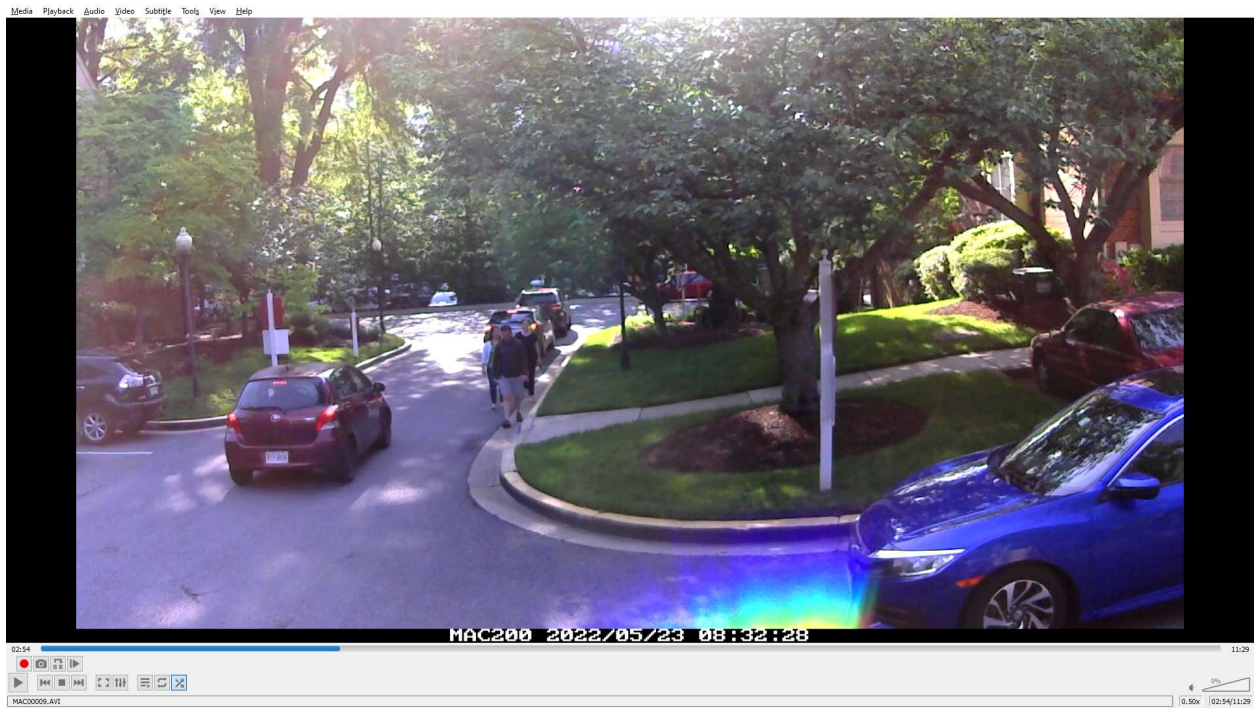
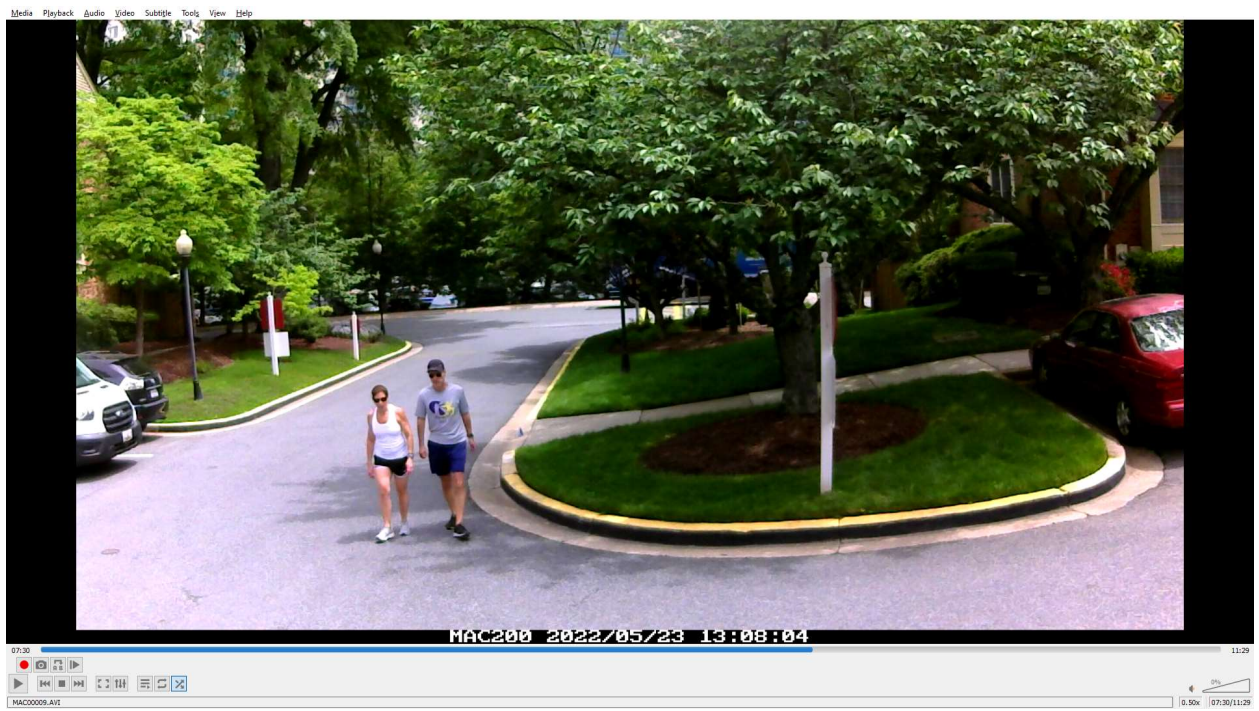
Note: Red circle highlights that some pedestrians do use the existing sidewalk.

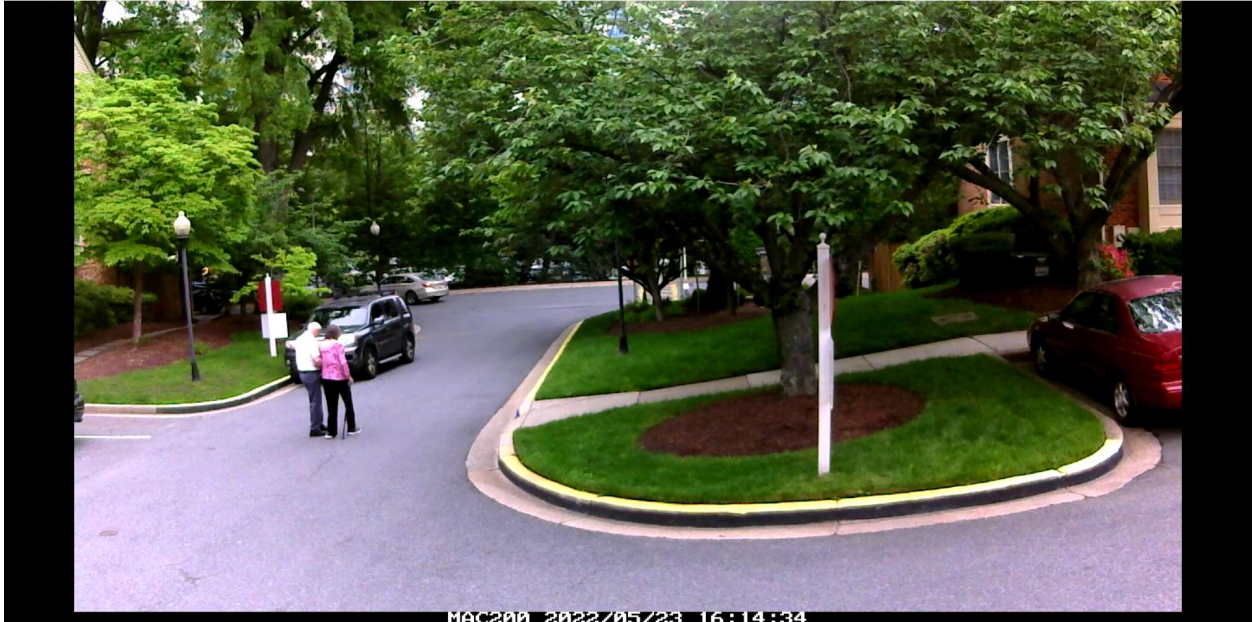
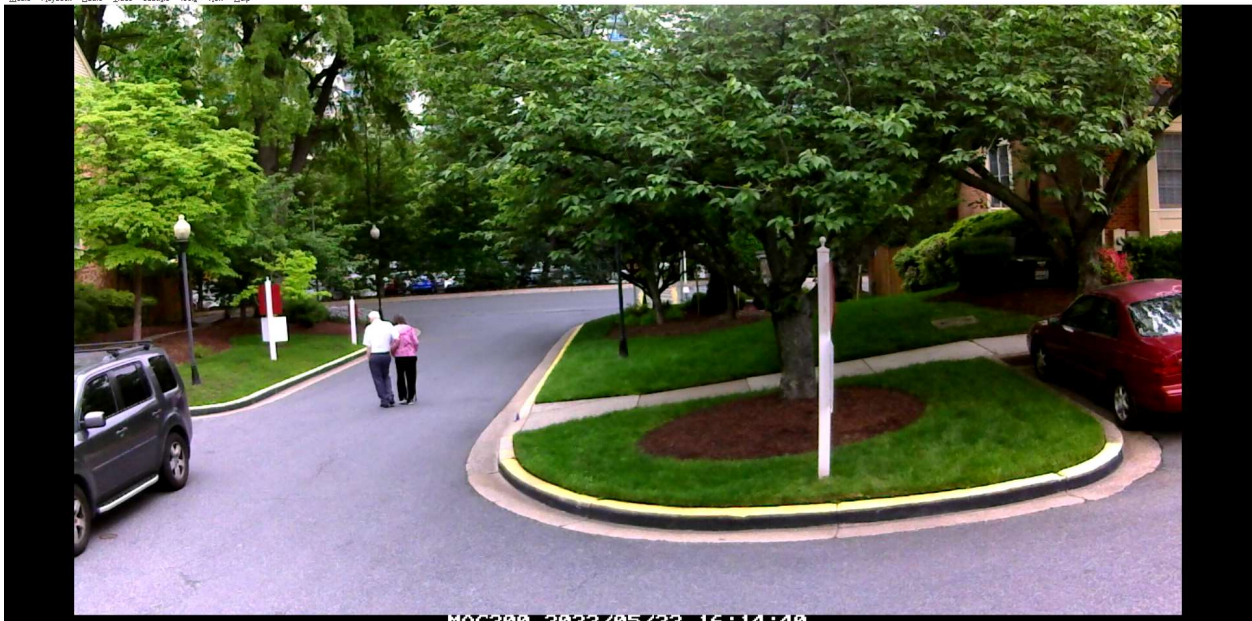
End of Englishman Drive

Children play within the circle area, riding bikes around the island and gathering at the southeast end of the island. While there appears to be children playing in the street, speeds in the general area were observed at reasonable speeds. Safe stopping sight distance to this area at the recorded speeds provides enough area to avoid conflicts. Children should be warned to stay as alert as possible for approaching vehicles and to take a safe position along the curb line and if possible, out of the paved area to avoid injury.

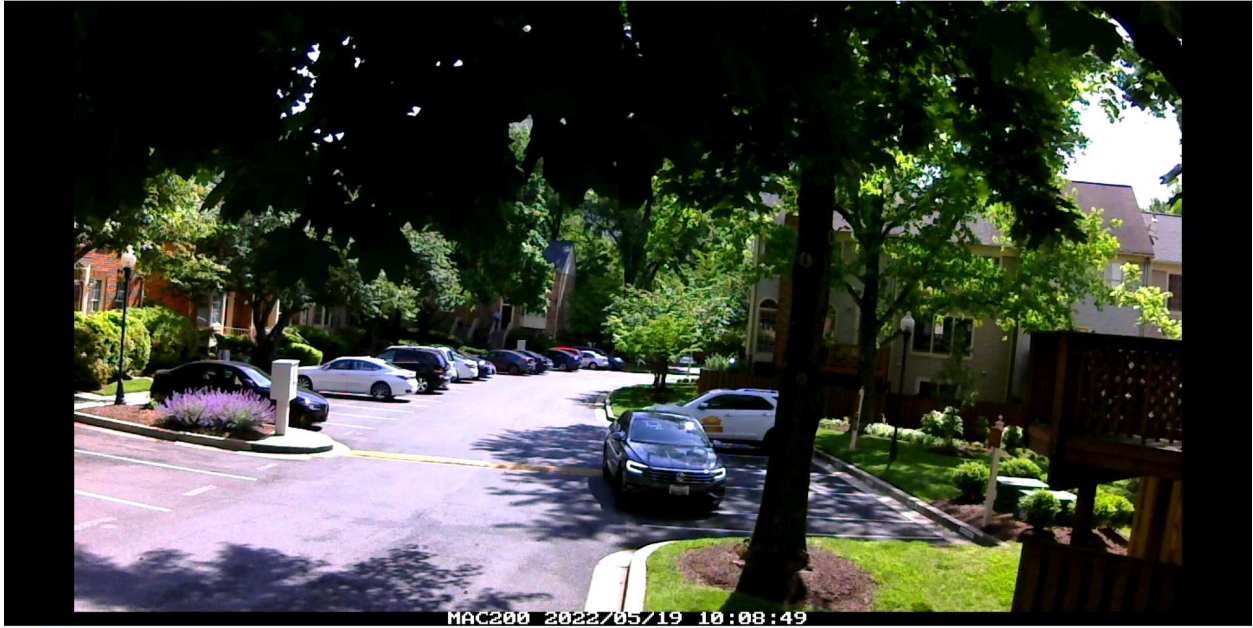
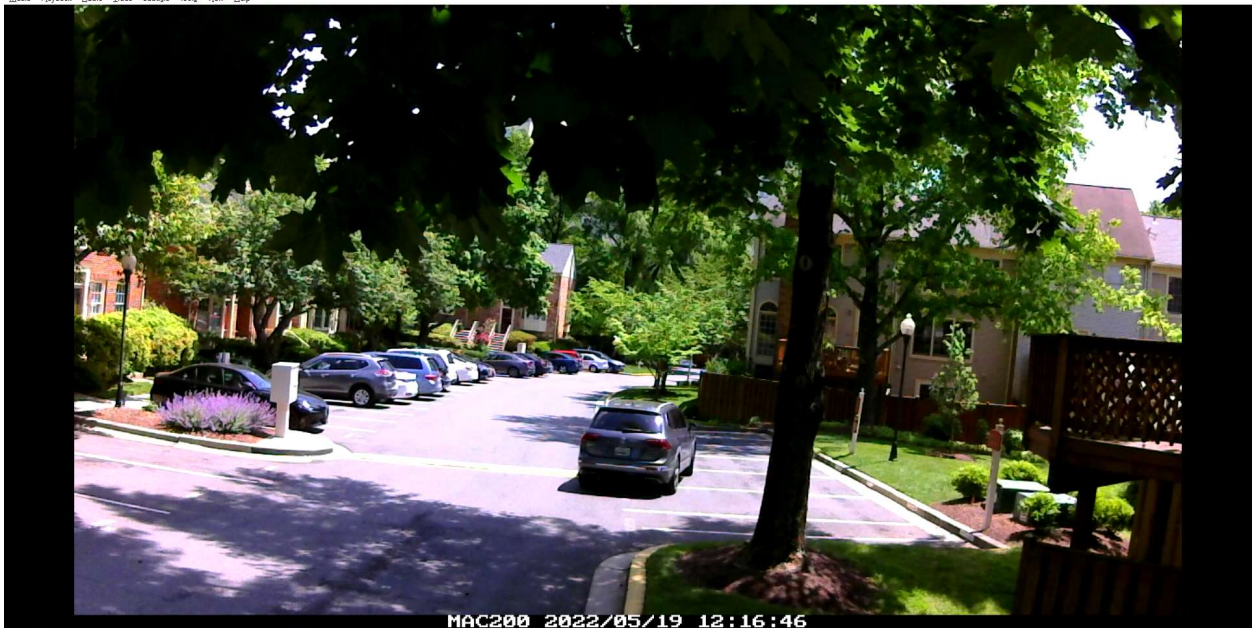
Existing Speed Bump adjacent to the existing Motorcycle Spaces: When the parking spaces are empty adjacent to this speed bump, vehicles were observed on multiple occasions driving around the bump to avoid it all together. Vehicles were observed avoiding the speed bump even in the opposite direction.

Recommendation: Remove the existing bump and install 1 new bump one parking space to the west (1 space closer to the tree within the photograph). This shift of the speed bump 1 space to the west will make it difficult to maneuver around the bump at a higher speed in either direction. The shift will create a parking space area along the north side of Grove Ridge Way but the space of one missing parked vehicle will not allow vehicles to drive around the bump at a higher speed.

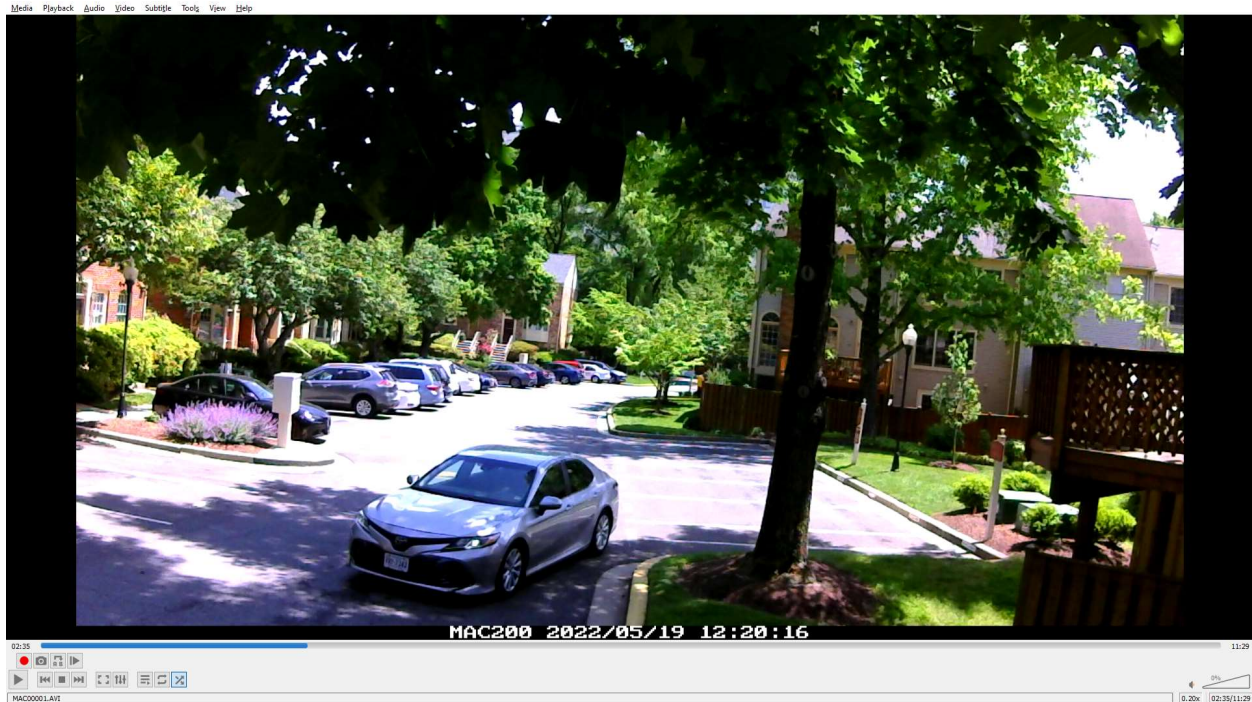
Internal pavement markings including the marking of visitor and reserved parking spaces:

- A. Pavement markings were observed faded and sometimes unreadable. Should be repainted.
- B. Yellow curb areas were observed faded in some areas. Should be repainted.
- C. Crosswalk should provide clear marked pedestrian path with white lines.
